## Inspection Report

**Property Address:**  
11400 Crumley Ranch Rd  
Austin TX 78738

# PROPERTY INSPECTION REPORT FORM

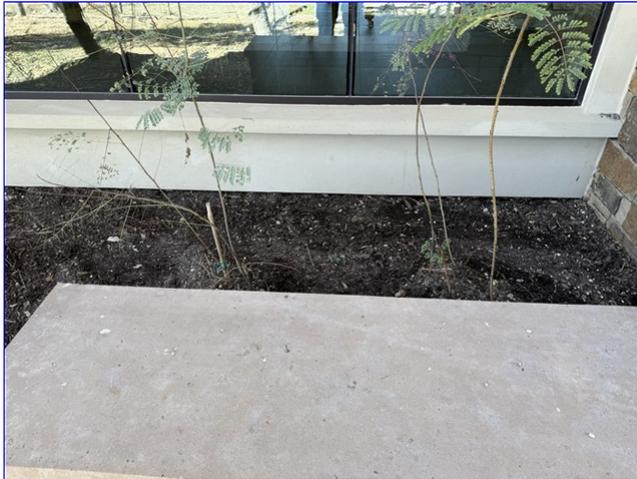
B. Item 1(Picture)

Item 1(Picture)Item 2(Picture) Lower grade in flower bed on back of house at back patio. There should be approx. 4-6" of foundation visible and water should drain away from foundation.

Item 1(Picture)Item 2(Picture) Lower grade in flower bed on back of house at back patio. There should be approx. 4-6" of foundation visible and water should drain away from foundation.

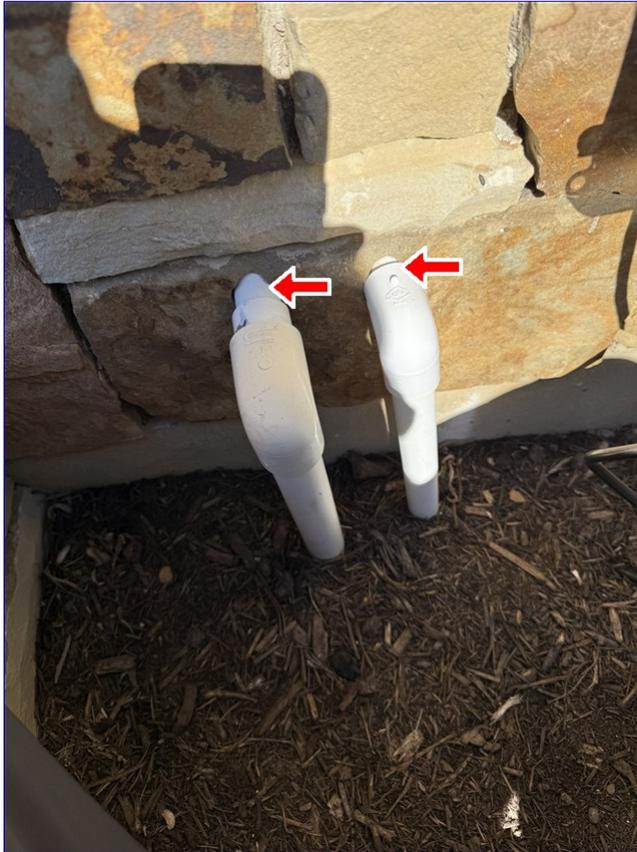
E. Item 3(Picture)

Item 3(Picture) Item 4(Picture)Item 5(Picture) Recommend that all penetrations through the walls be properly sealed so water, bugs, and debris do not enter the wall space. This includes all light fixtures, hose bibs, plumbing lines, HVAC lines, exhaust vents, electrical boxes, and cables.

Item 3(Picture) Item 4(Picture) Item 5(Picture) Recommend that all penetrations through the walls be properly sealed so water, bugs, and debris do not enter the wall space. This includes all light fixtures, hose bibs, plumbing lines, HVAC lines, exhaust vents, electrical boxes, and cables.

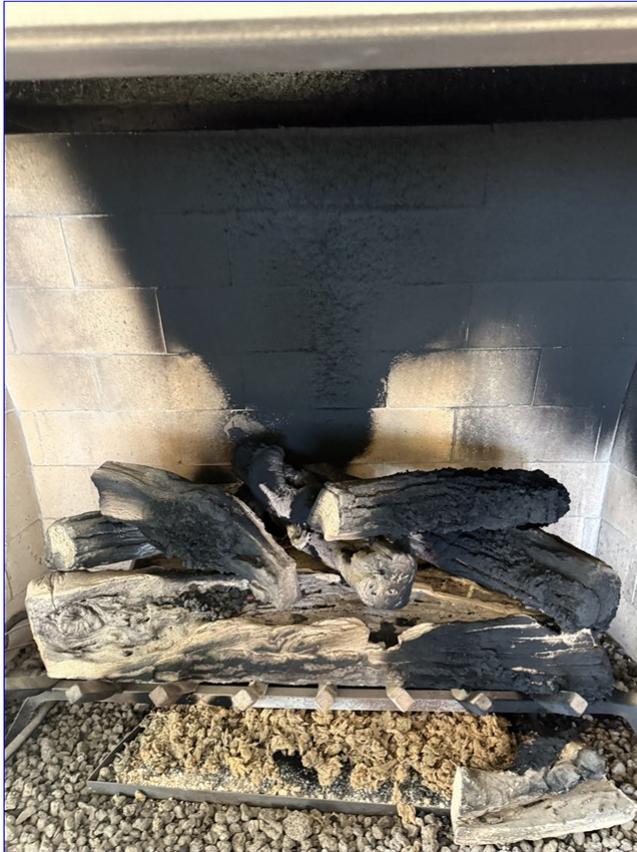
J. Item 4(Picture)

Item 4(Picture) Item 5(Picture) Excessive amount of soot build up in fireplace. Recommend that the fireplaces have a Level 2 inspection by a qualified certified chimney sweep upon sale or transfer of property per NFPA211 15.4

Item 4(Picture) Item 5(Picture) Excessive amount of soot build up in fireplace. Recommend that the fireplaces have a Level 2 inspection by a qualified certified chimney sweep upon sale or transfer of property per NFPA211 15.4

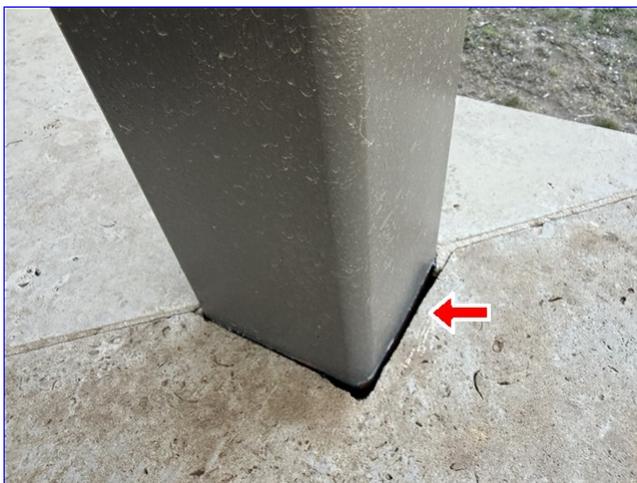
K. Item 1(Picture)

Item 1(Picture) Seal around metal post on back patio.

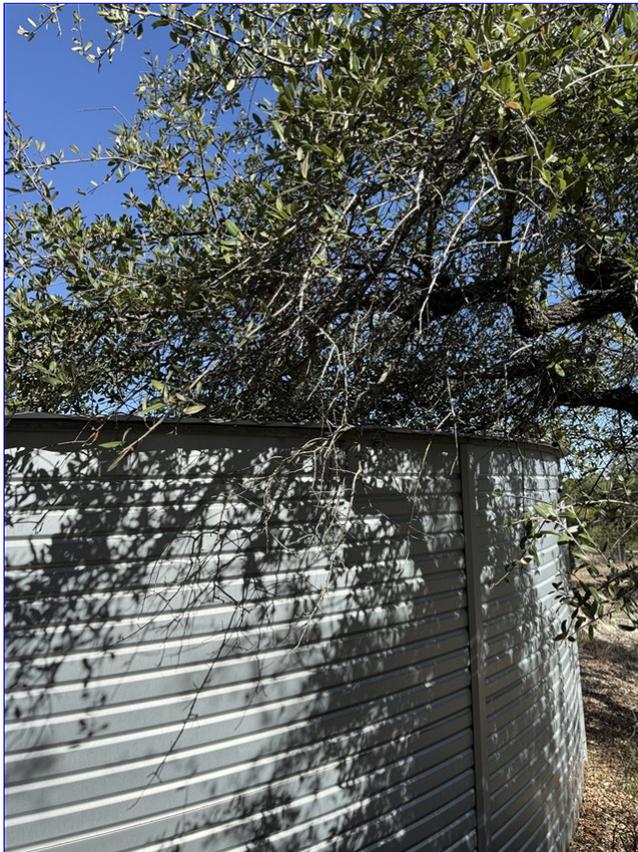
M. Item 5(Picture)

Item 5(Picture) Trim tree limbs from rain water collection tank as needed.

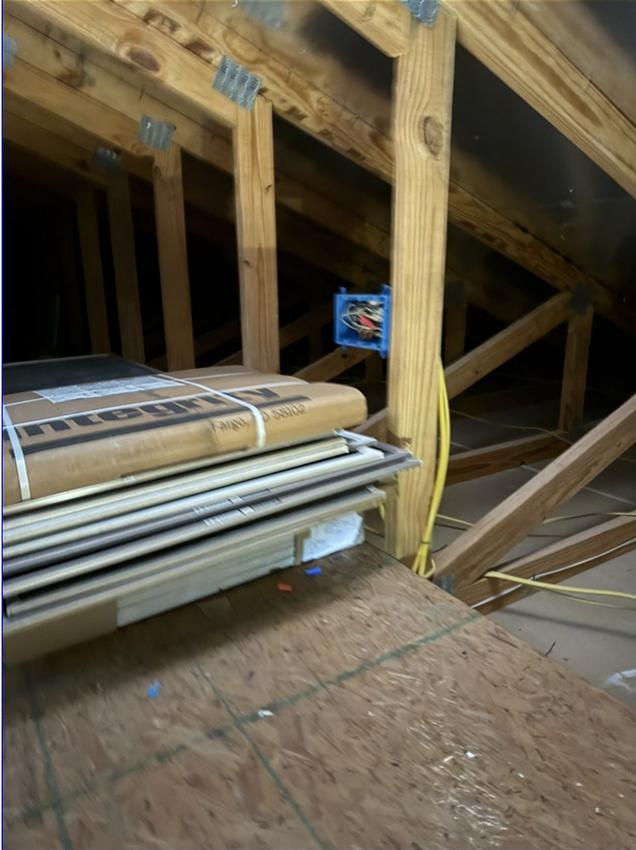
B. Item 1(Picture)

Item 1(Picture) Missing cover on electric junction box.

Item 1(Picture) Missing cover on electric junction box.

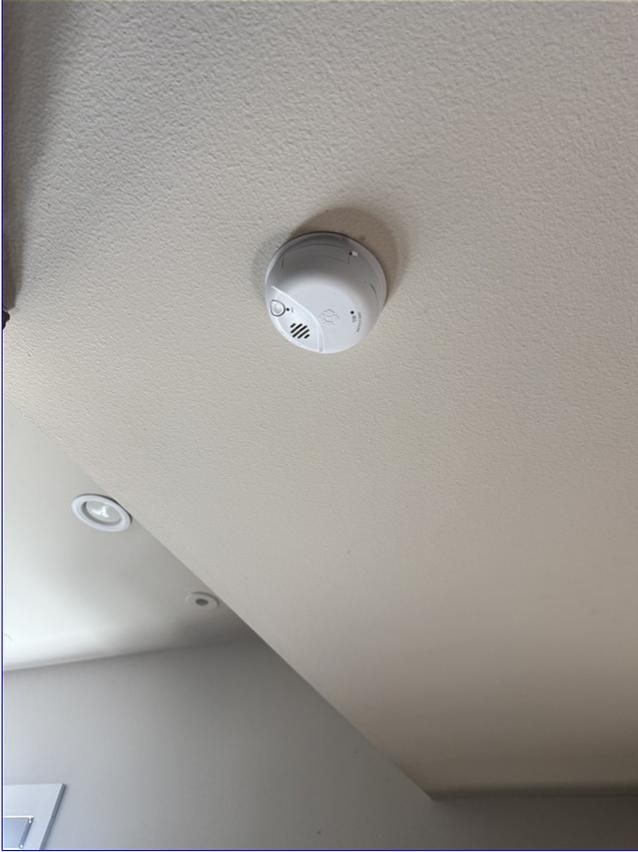
B. Item 3(Picture)

Item 3(Picture) All smoke detectors and carbon monoxide detectors over ten years old should be replaced. Test monthly.

Item 3(Picture) All smoke detectors and carbon monoxide detectors over ten years old should be replaced. Test monthly.

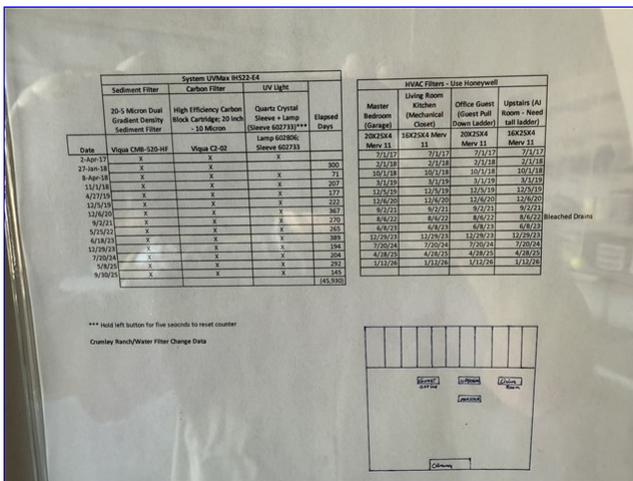
D. Item 1(Picture)

Item 1(Picture) List showing filters for water treatment and HVAC.

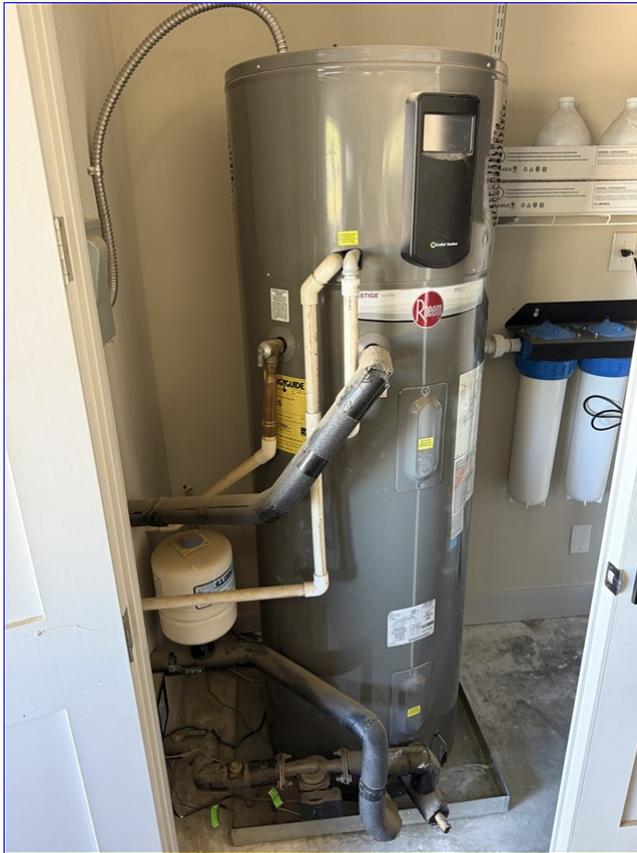
C. Item 1(Picture)

Item 1(Picture)Item 2(Picture) Rheem 80 gallon electric water heater.

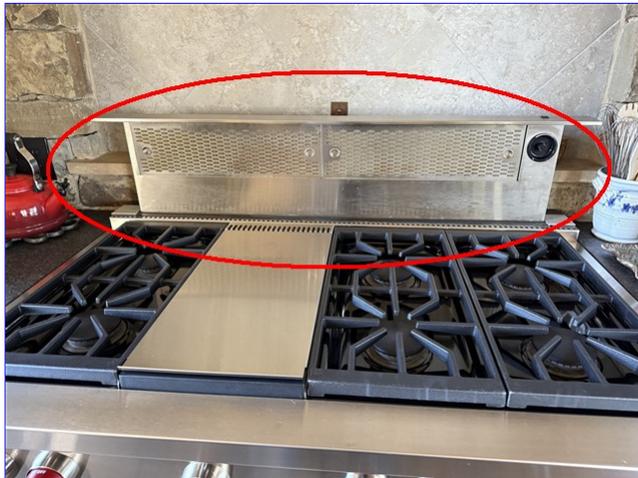
C. Item 1(Picture)

Item 1(Picture) Item 2(Picture) Recommend that the grease filter be cleaned occasionally depending on the amount of use.

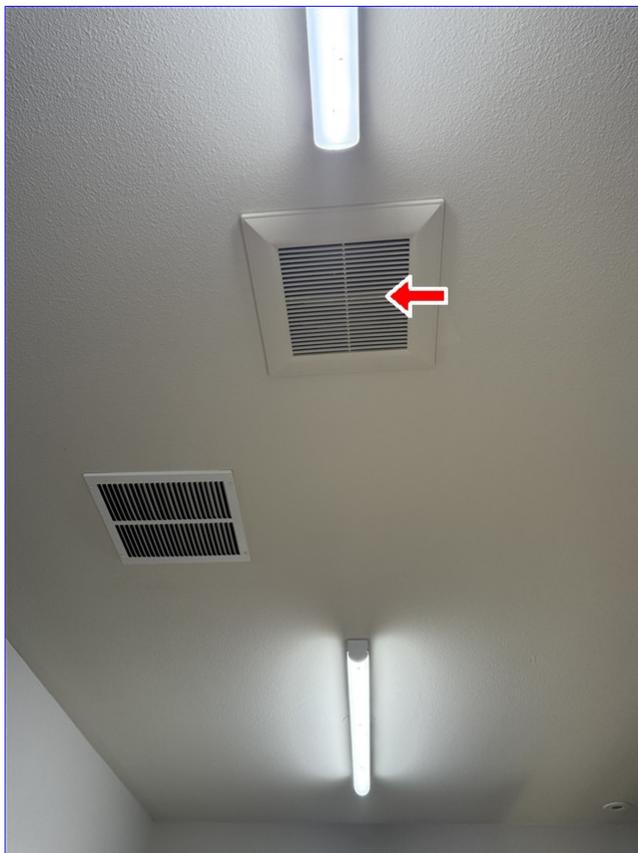
H. Item 1(Picture)

Item 1(Picture) Were performing as intended at time of inspection. It is recommended that the exhaust fans be cleaned occasionally to remove built up dust.

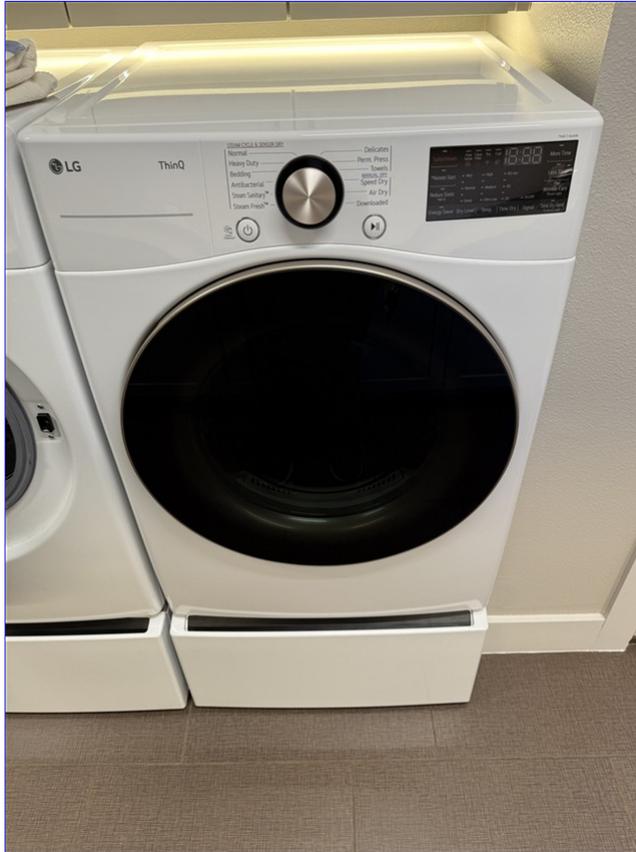
J. Item 1(Picture)

Item 1(Picture) I did not inspect the dryer venting since it was connected to dryer. Recommend that the dryer vent be cleaned annually.

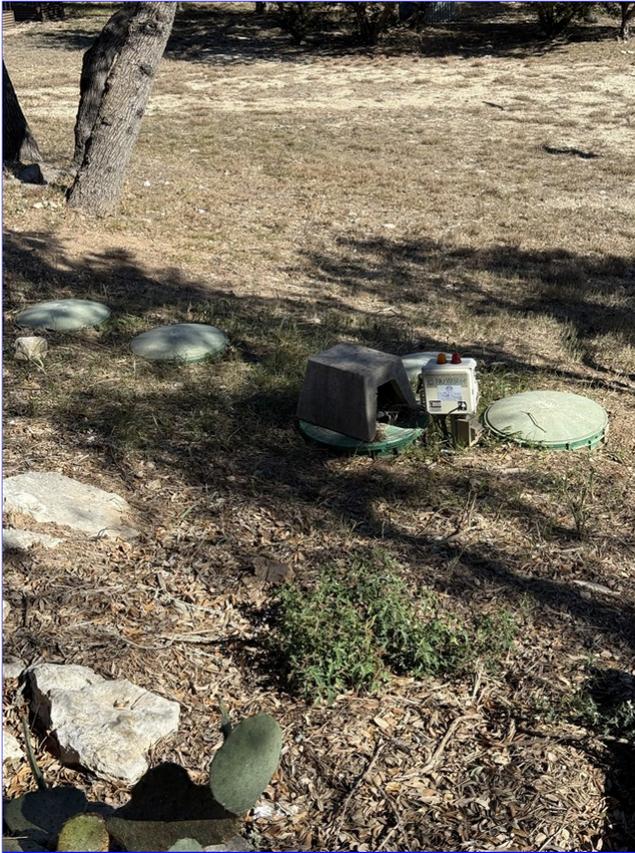
E. Item 1(Picture)

Item 1(Picture) I did not inspect the septic system or any of its components.
